# Manhole Inspection Summary

Manhole # S02CC2011MH

Insp Date: **7/20/06 7:23 AM**

**Location** Address: **6606 Cross Country Blvd**

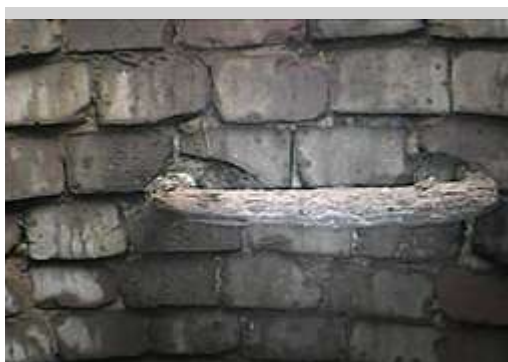
Defect

**Steps** Count: **2** Missing: **0** ☒ **Corroded**

corroded steps

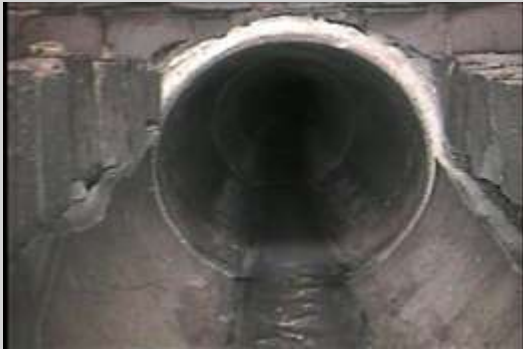
### 12 in. Circular Gravity Sewer Pipe Out @ 12 O'Clock

Rod and Bar (Angled)

Pipe Material: **Clay** ☐ Pipe Lined

Invert Depth: **5.33** (ft.) Flow Characteristics: **Slow**

Deposits: ☒ None ☐ Mud ☐ Sludge ☐ Debris ☐ Grease

Infiltration: **None** Pipe Seal Cond: **Sound**

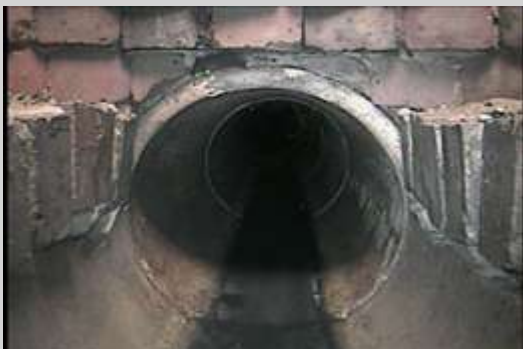
### 12 in. Circular Gravity Sewer Pipe In @ 6 O'Clock

Rod and Bar (Angled)

Pipe Material: **Clay** ☐ Pipe Lined

Invert Depth: **5.46** (ft.) Flow Characteristics: **Slow**

Deposits: ☒ None ☐ Mud ☐ Sludge ☐ Debris ☐ Grease

Infiltration: **None** Pipe Seal Cond: **Sound**
